California Levee Vegetation Research Program

Influence of Tree Roots and Mammal Burrowing Activity on Levee Integrity:

Volume 4. – Field Evaluation of Burrowing Animal Impacts and Effectiveness of Remedial Measures

Geotechnical Engineering
University of California, Berkeley
Report UCB GT 13-03 vol. 4

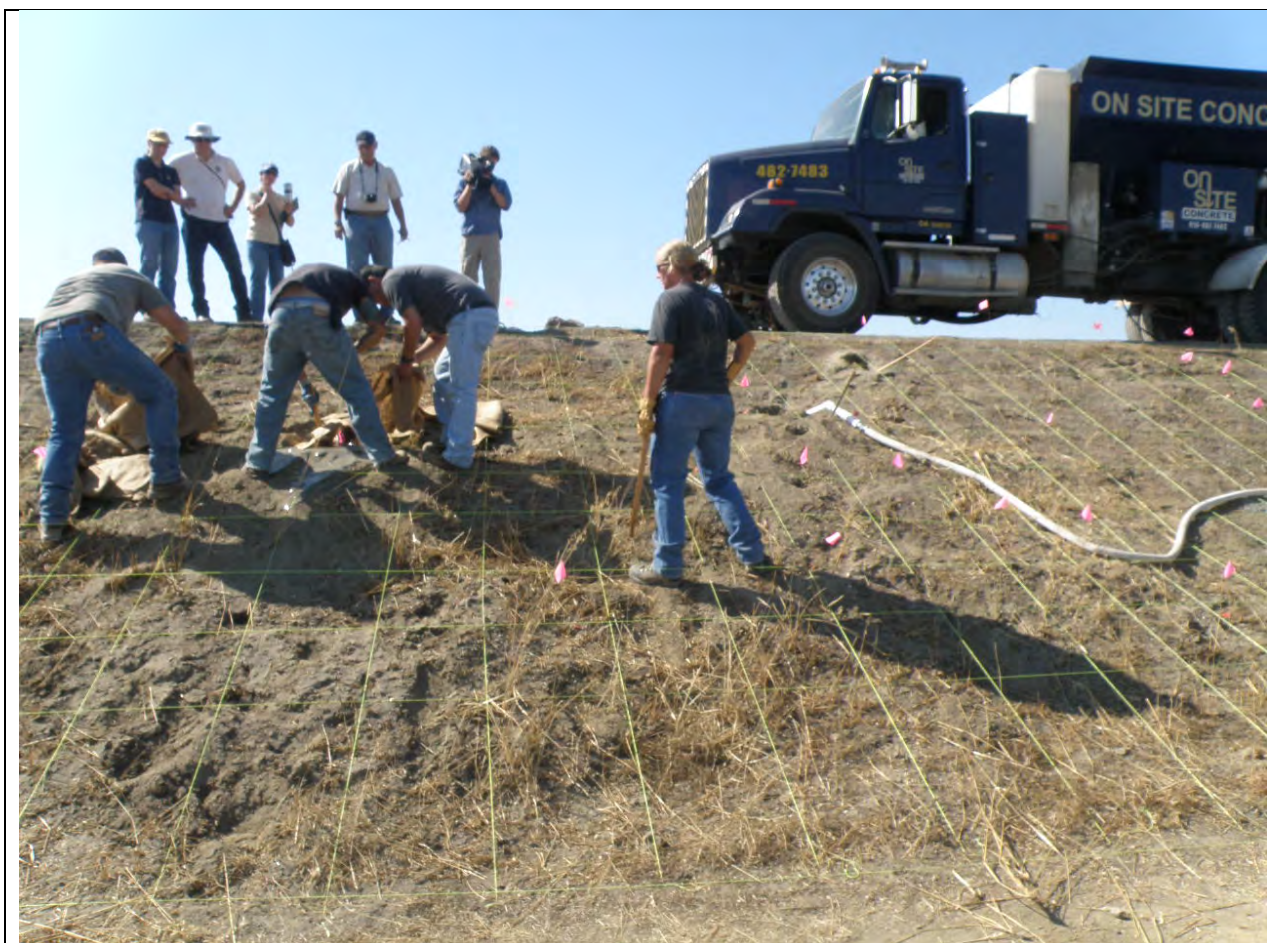
Photo 4A -6. Active ground squirrel burrow on landside slope that took over 15 minutes to grout using DWR's cement-bentonite mix.

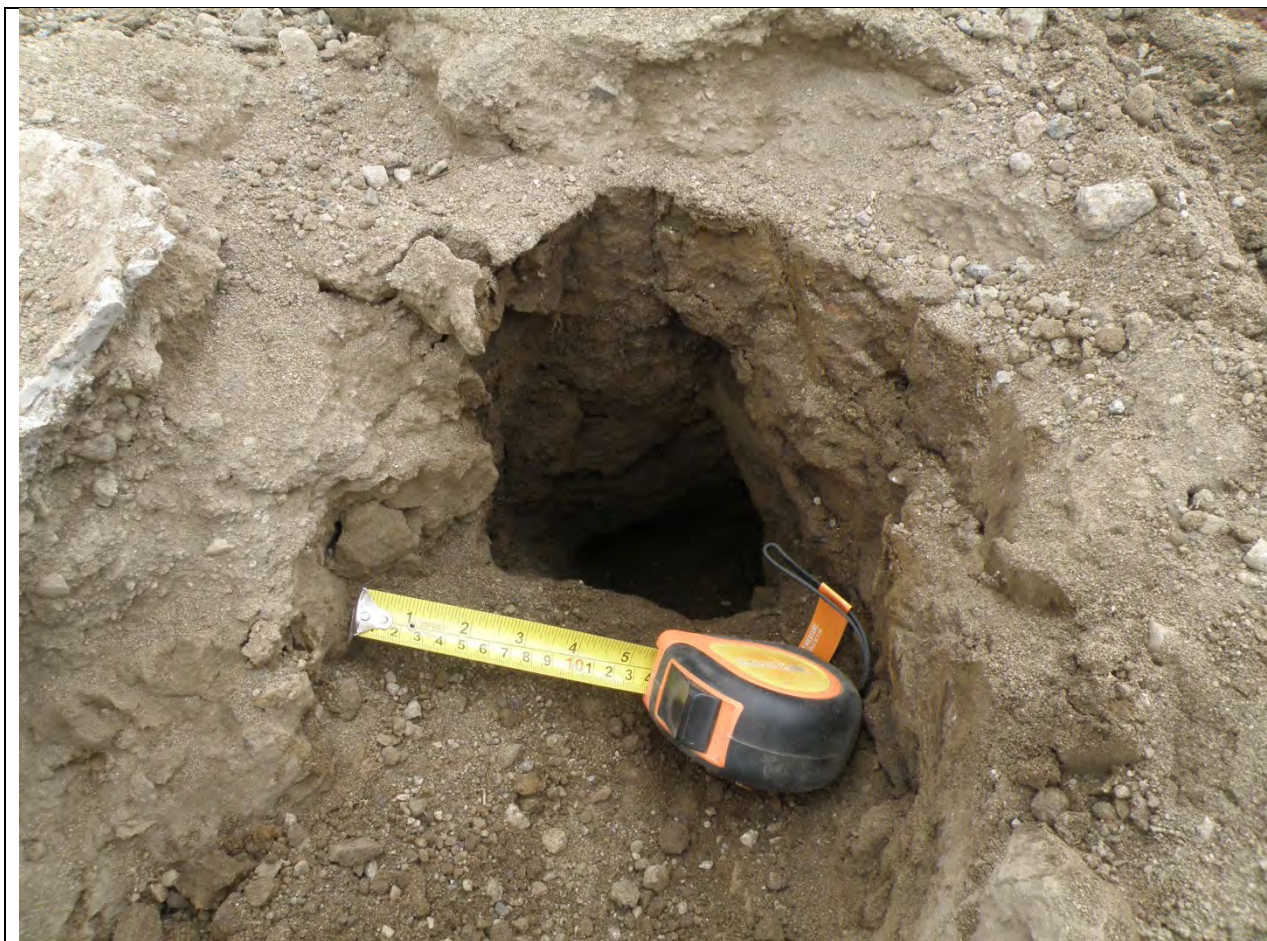
Photo 4A -10. View of ungrouted ground squirrel burrow on landside slope below road base material, Sandy Levee.

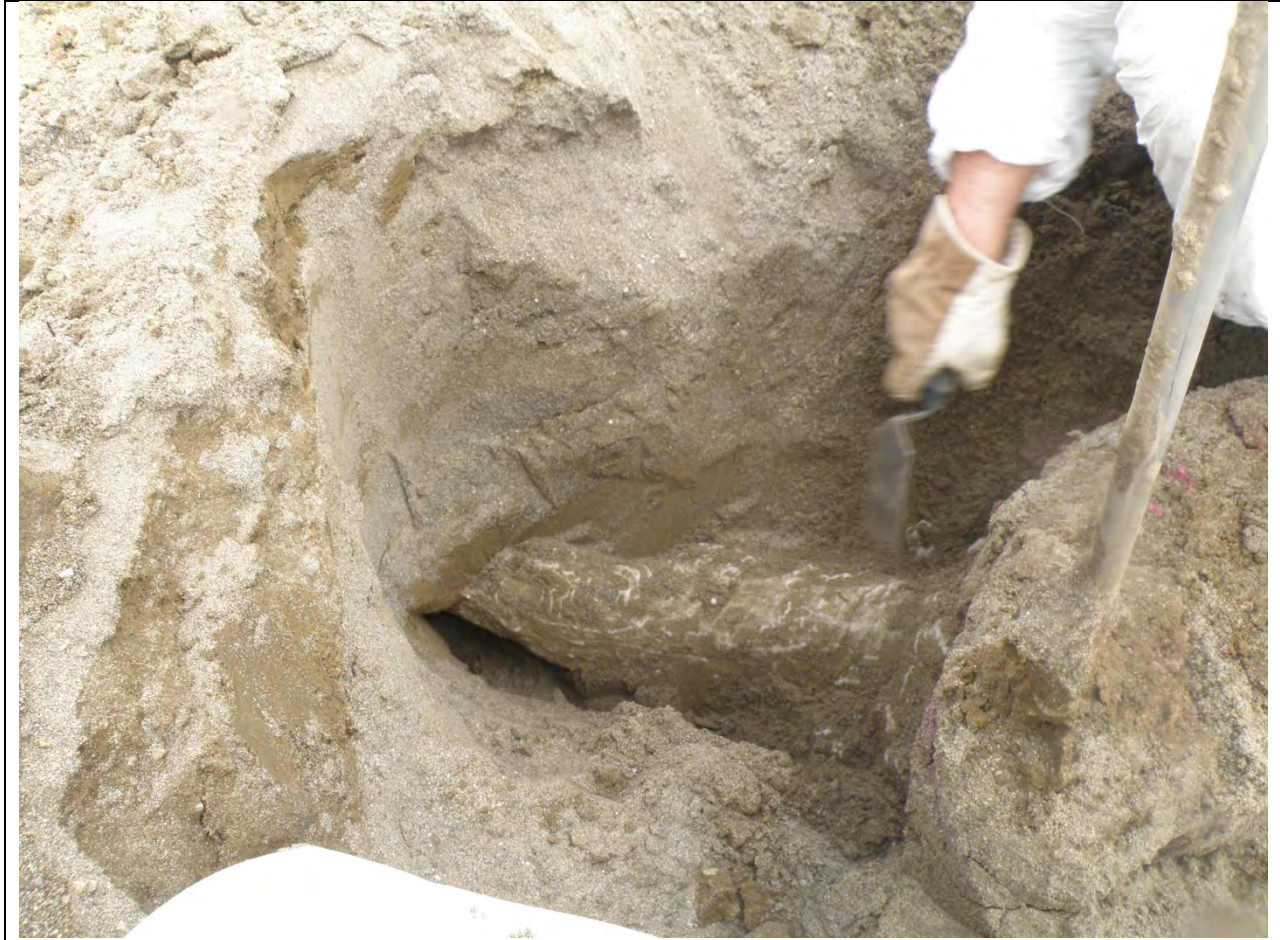
Photo 4A -11. View of newly discovered ground squirrel burrow next to large grouted burrow on waterside toe, Sandy Levee.

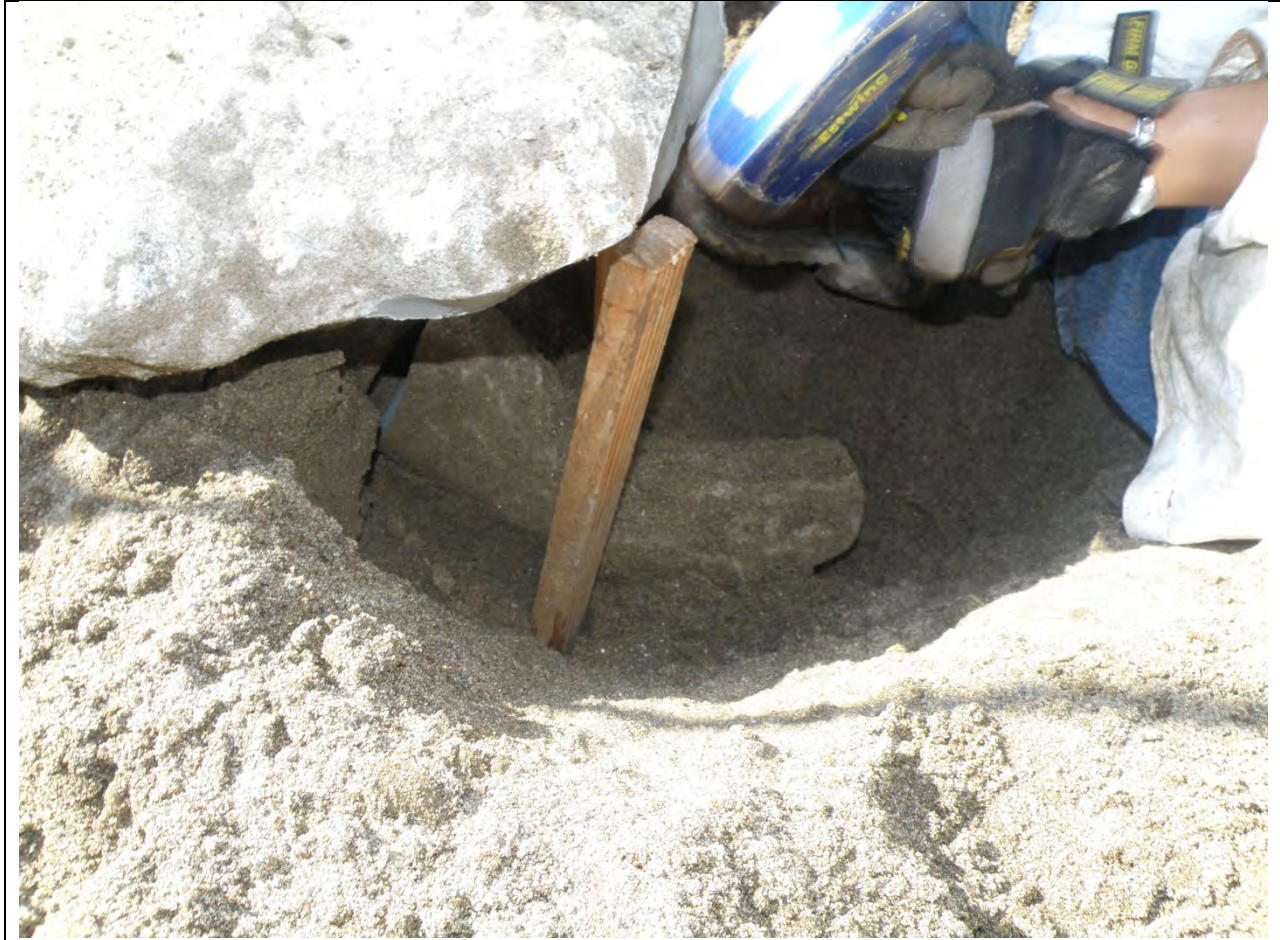
Photo 4A -12. Close up of ground squirrel den and small extension feature, Sandy Levee.

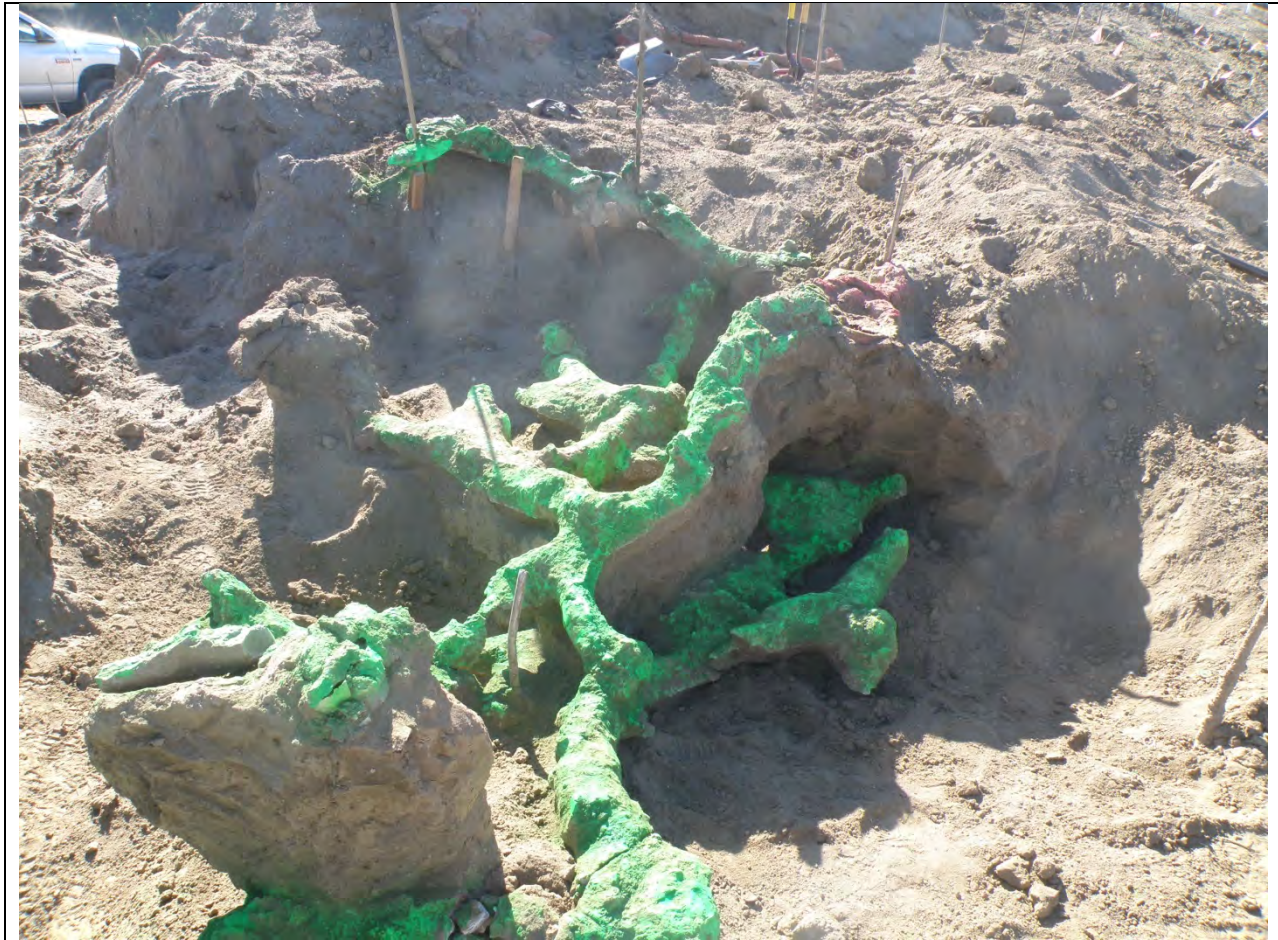
Photo 4A -14. View of intricate multi-level ground squirrel burrow complex on landside slope, Sandy Levee.

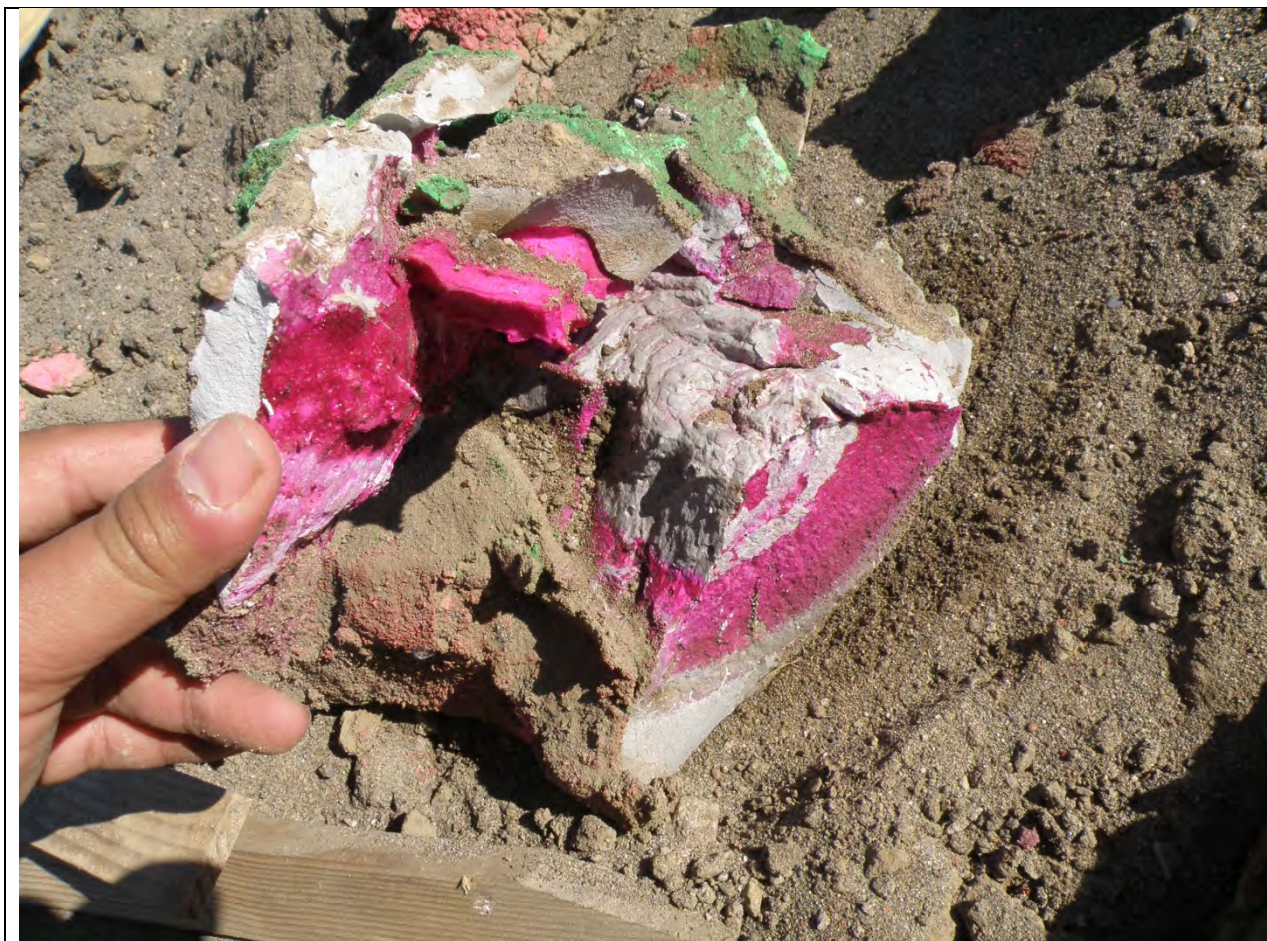
Photo 4A -17. Voids within cement-bentonite grout filled with urethane grout, Sandy Levee.

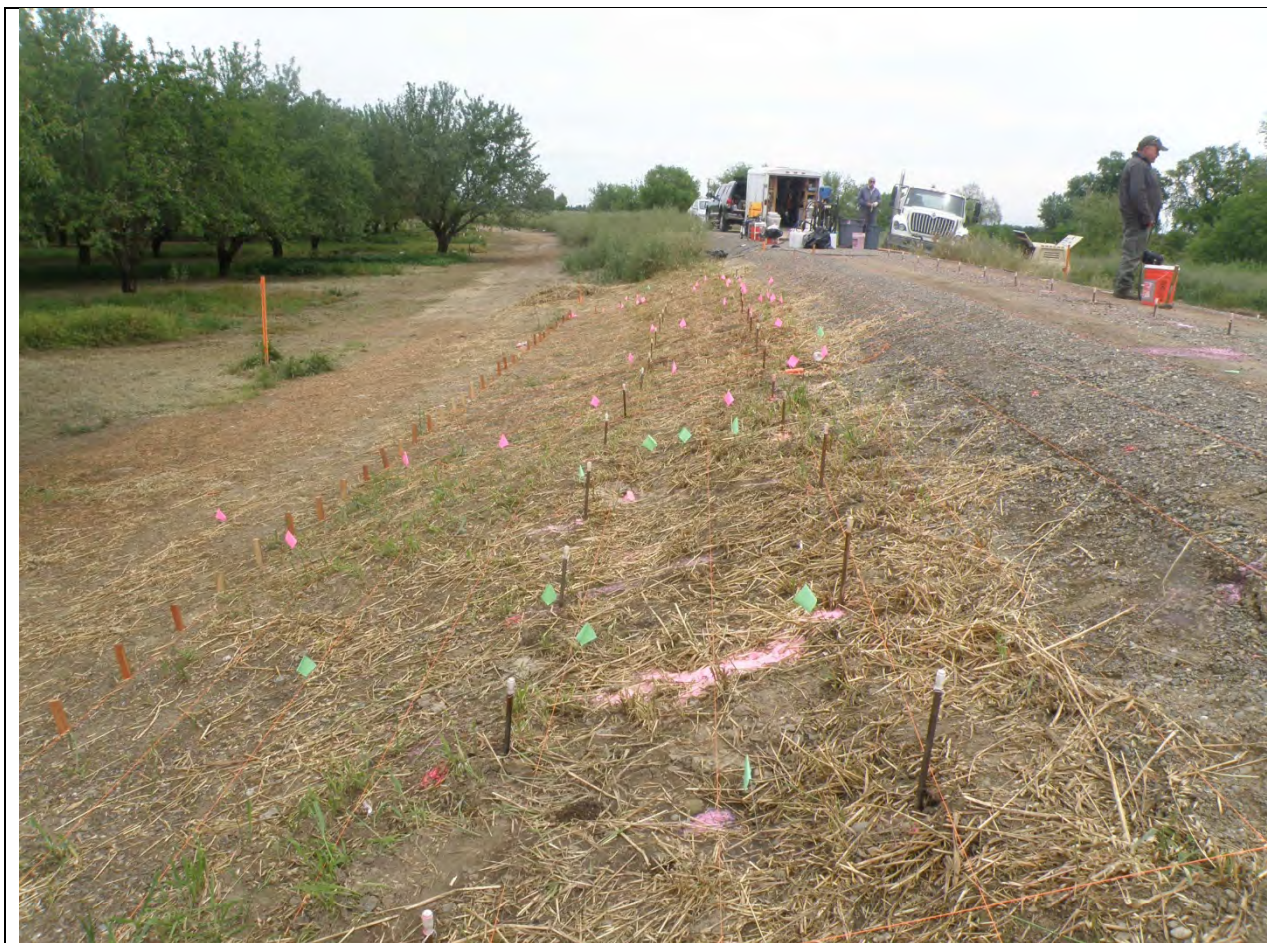
Photo 4A -18. View of ground squirrel burrows (green flags) and undifferentiated burrows (pink flags) along landside slope, Clayey Levee.

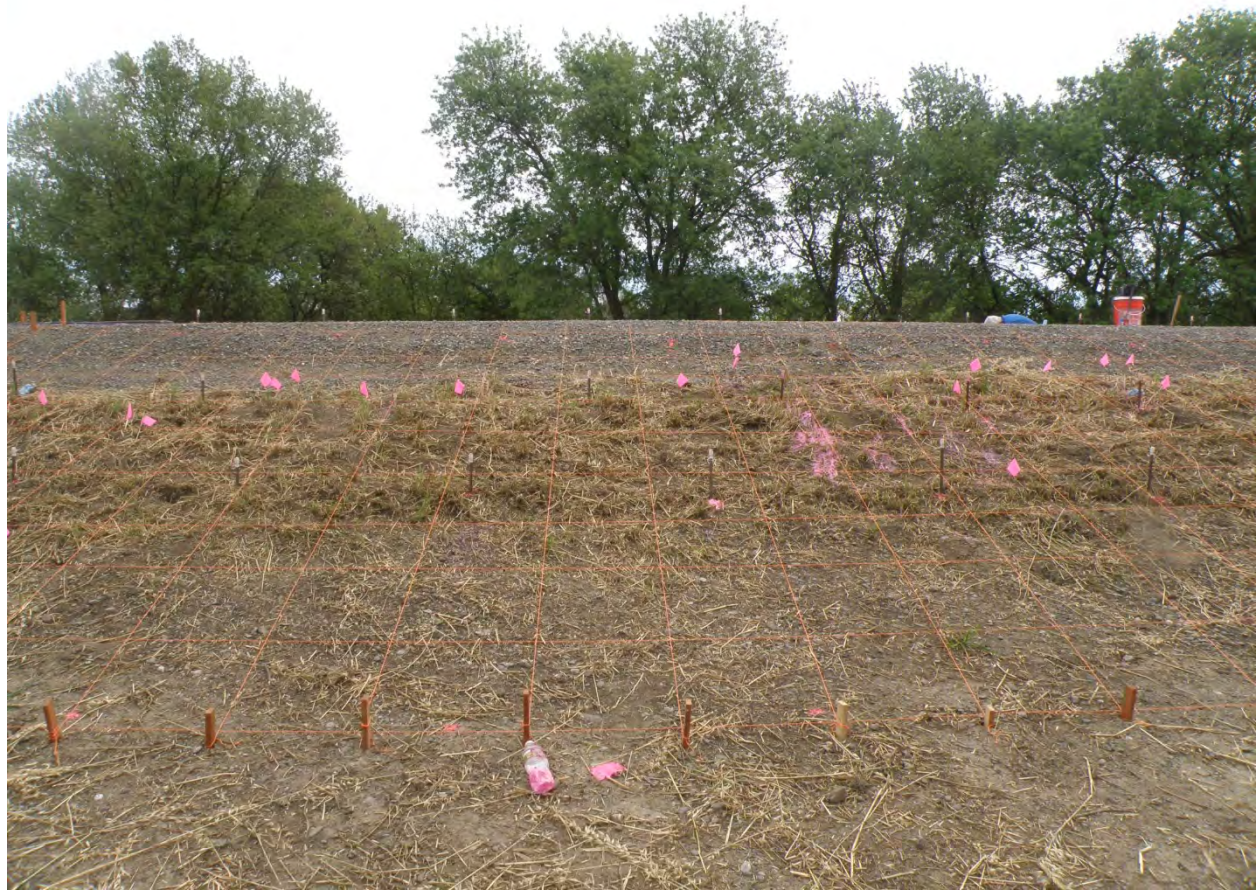
Photo 4A -19. View of ground squirrel burrows (green flags) and undifferentiated burrows (pink flags) along waterside slope, Clayey Levee.

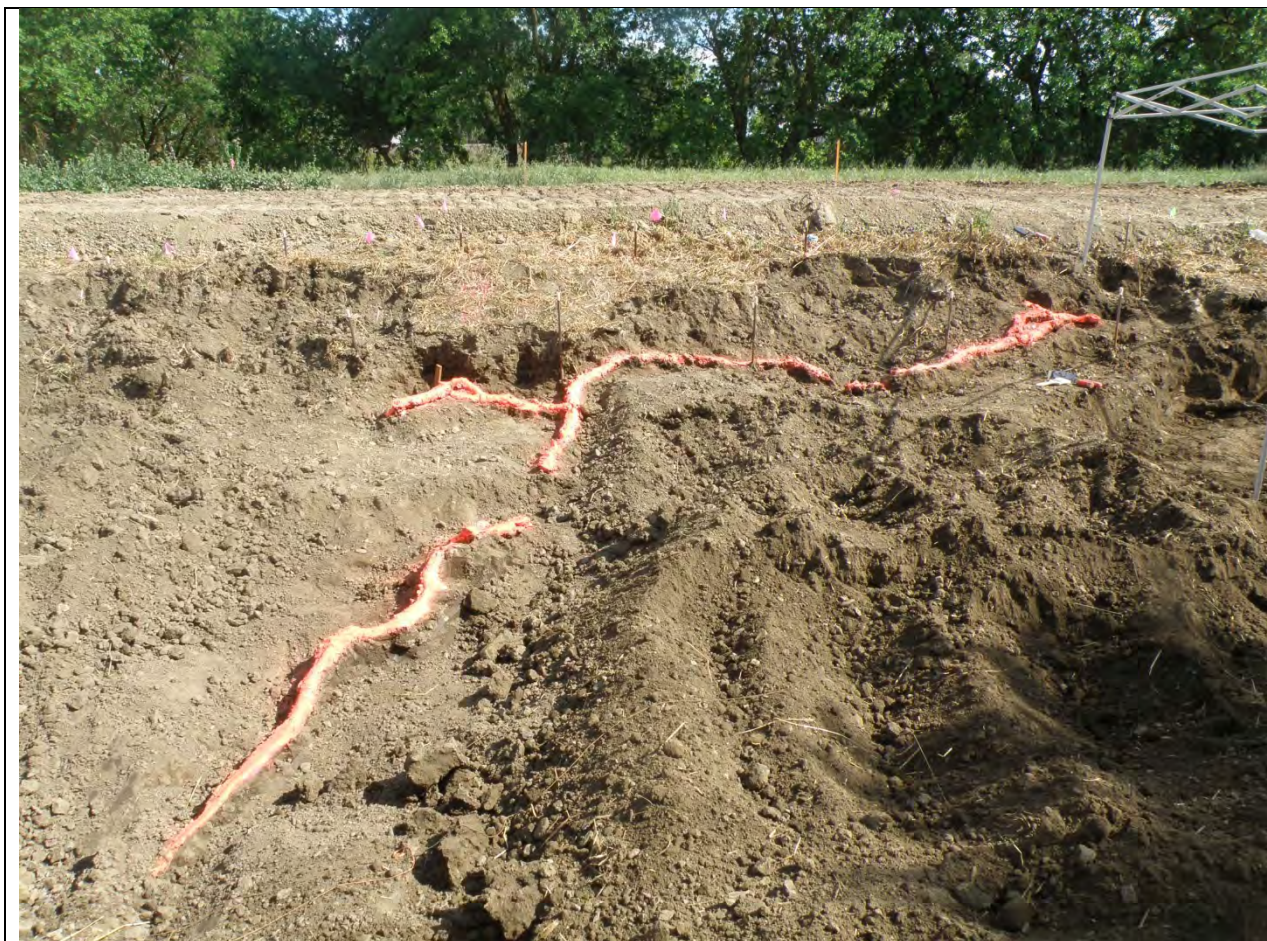
Photo 4A -23. Single continuous urethane-filled gopher burrow extending several meters along landside slope, Clayey Levee.

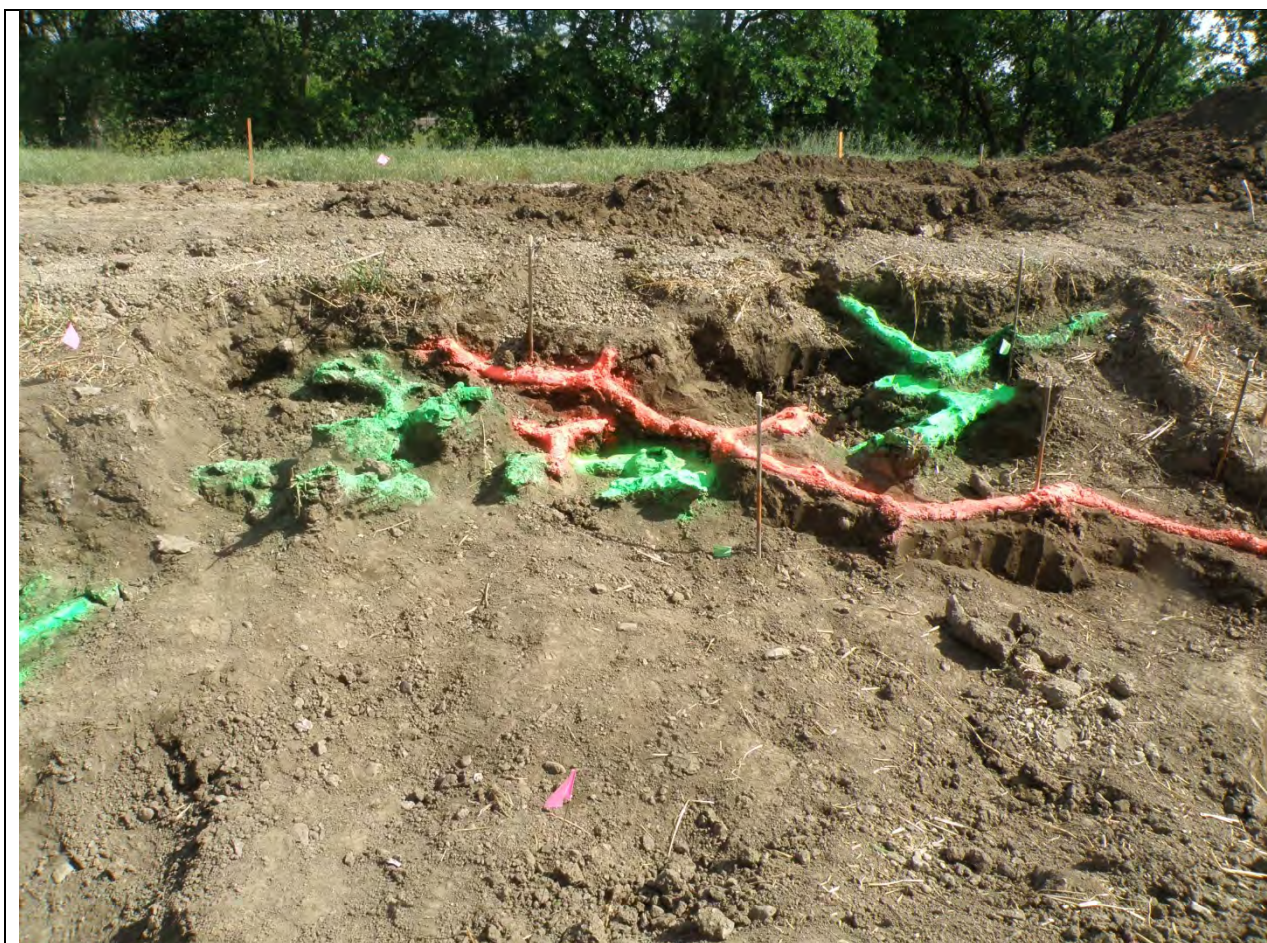
Photo 4A -24. View of interconnected urethane grouted ground squirrel and gopher burrows and previously cement-bentonite grouted burrows, Clayey Levee.

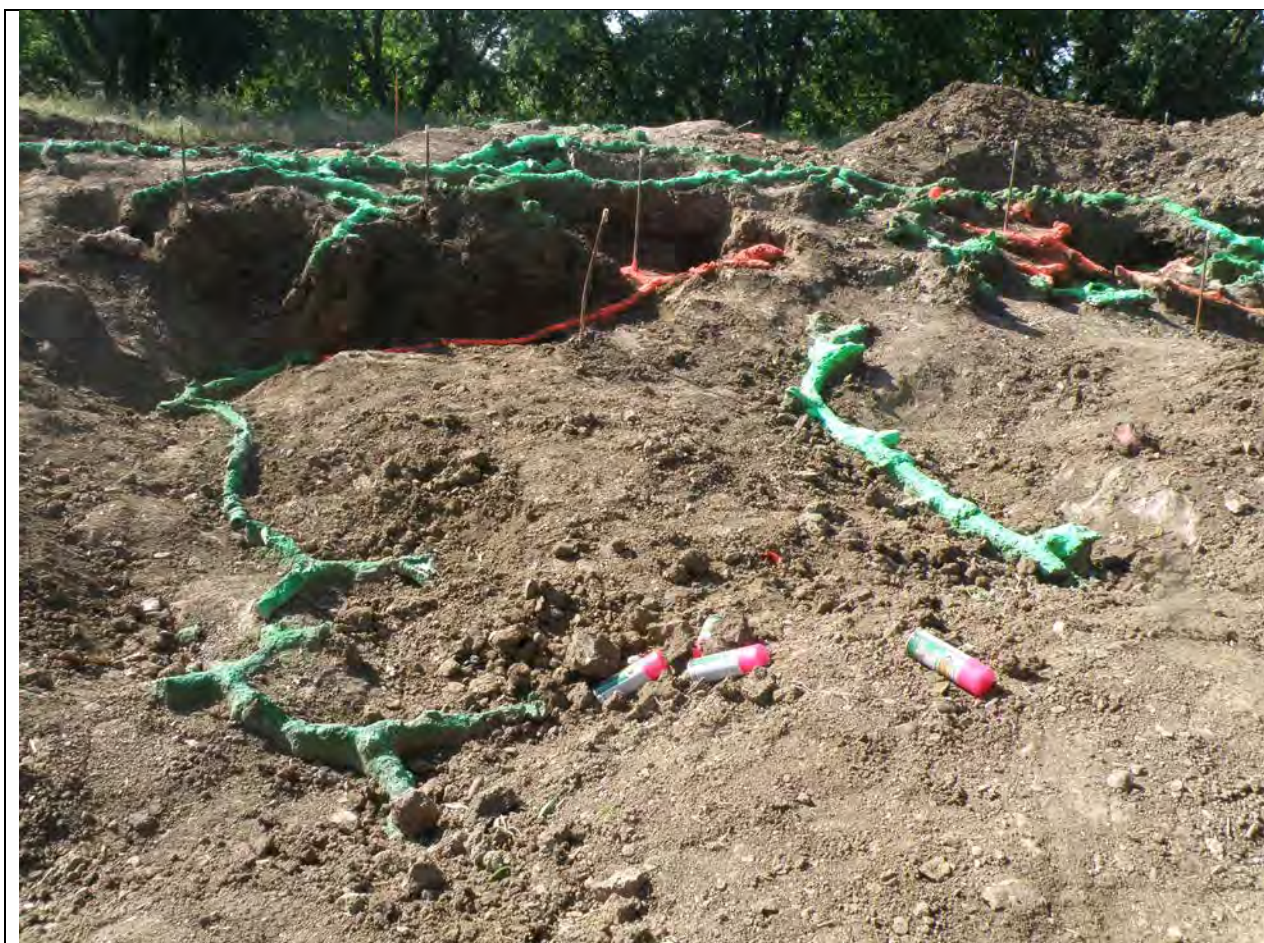
Photo 4A -26. View landside burrow complex showing several large burrows extending towards the toe, Clayey Levee.

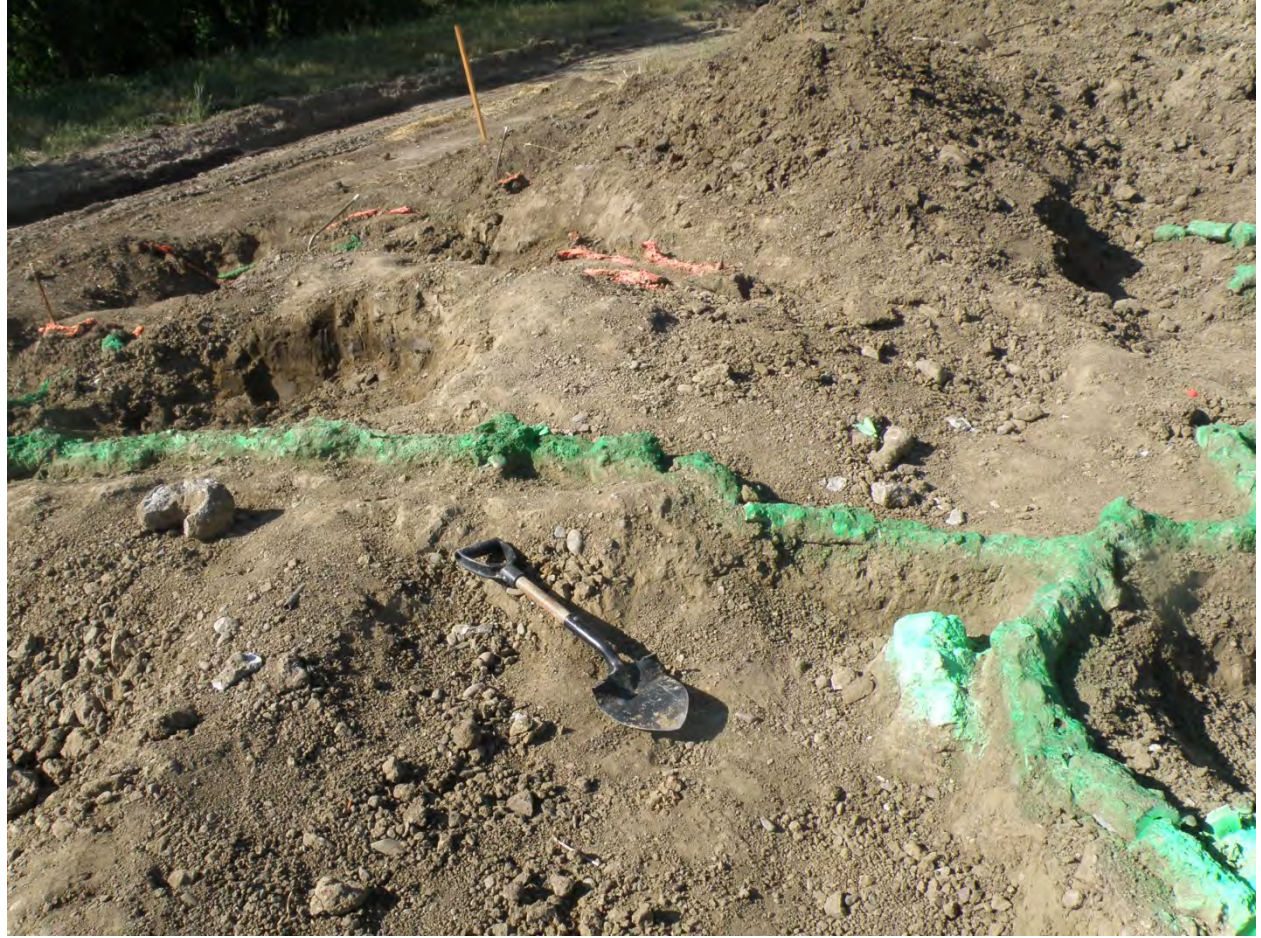
Photo 4A -27. View of completely penetrating ground squirrel burrow, waterside slope can be seen to the left of the image, Clayey Levee.

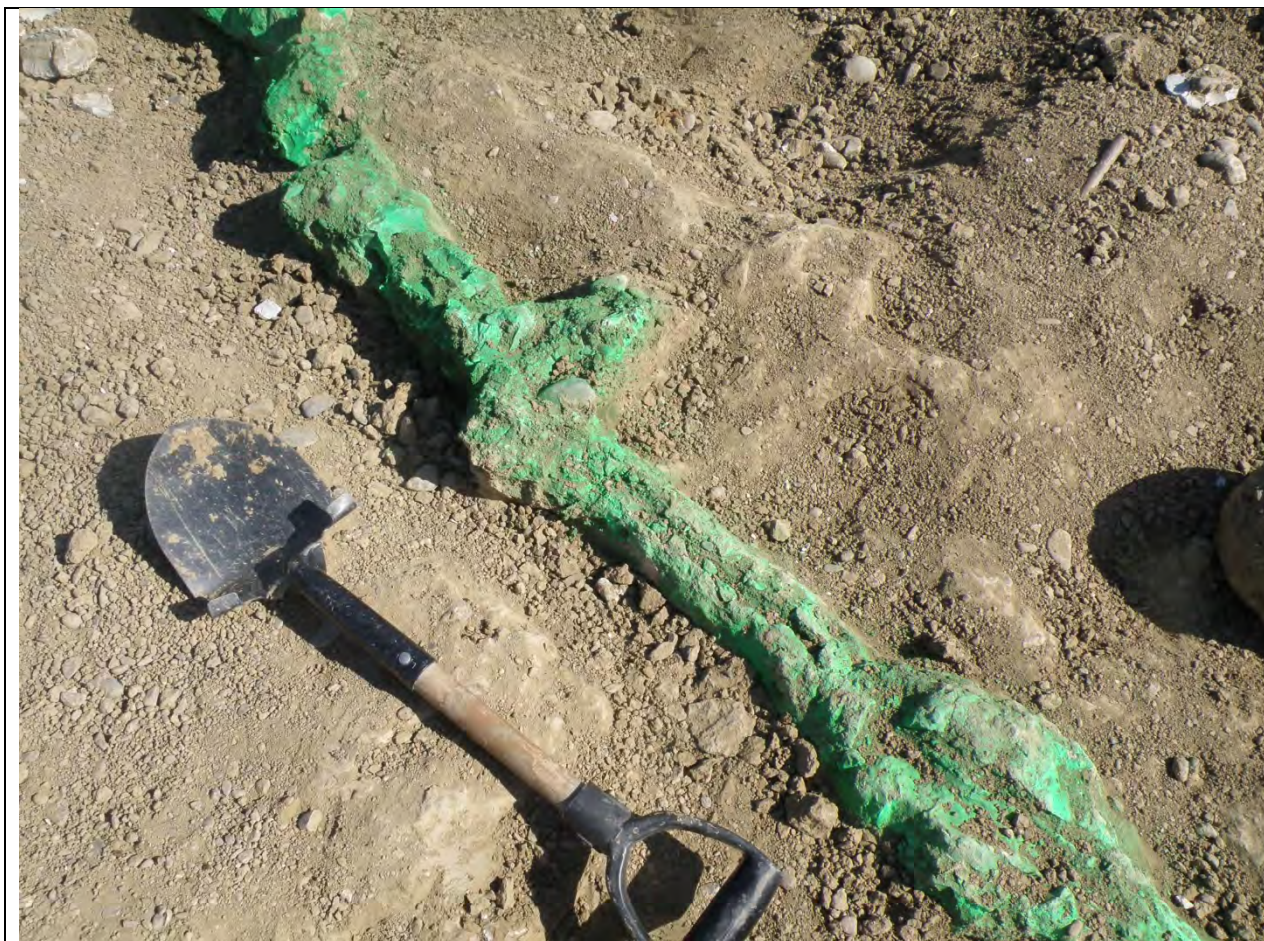
Photo 4A -28. Close up of completely penetrating ground squirrel burrow. Cement-bentonite grout along this burrow was friable and broken in several pieces, suggesting it was grouted during the early years of DWR grouting programs, Clayey Levee.

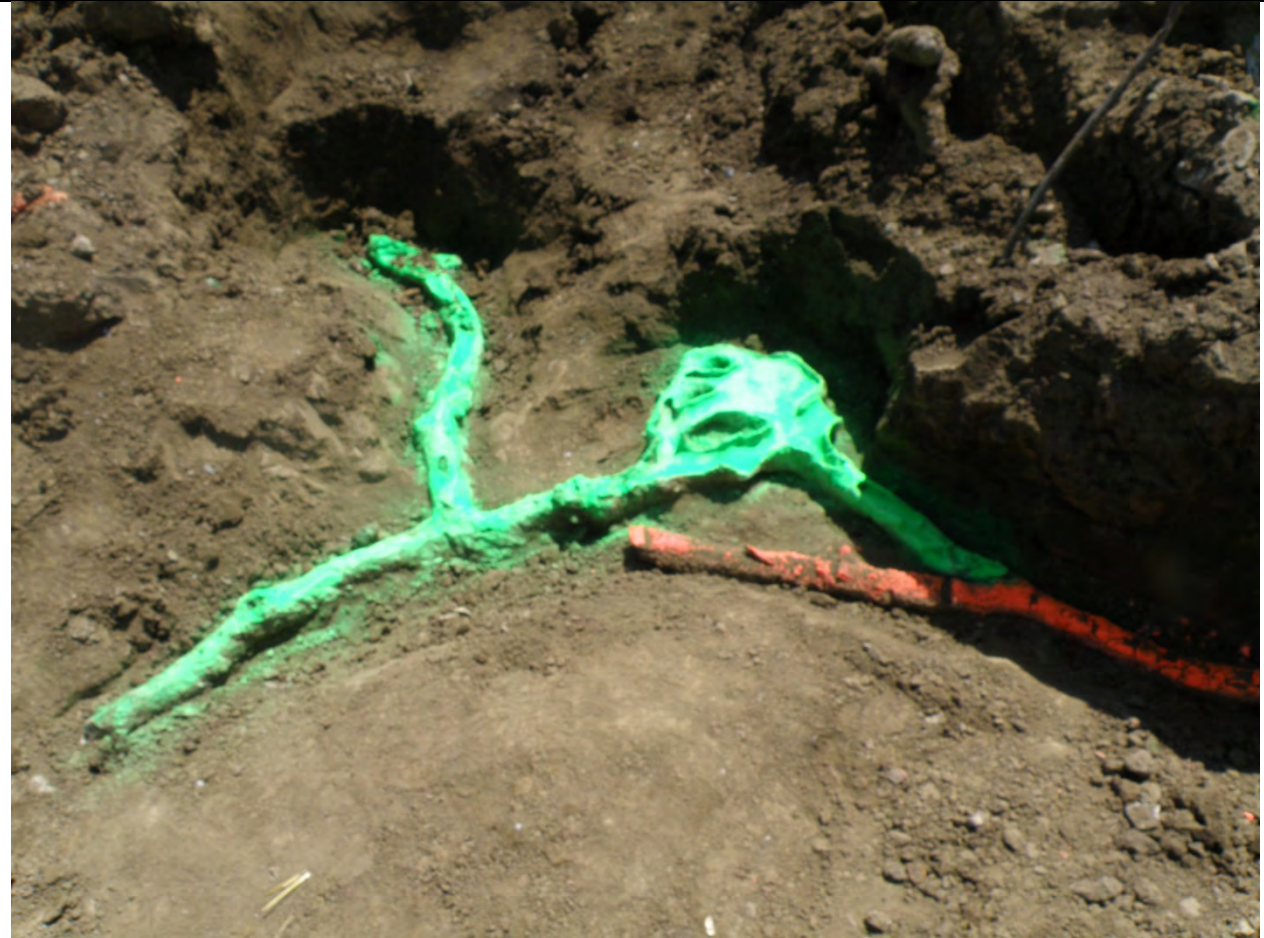
Photo 4A -30. View of partially cement-filled ground squirrel den on landside slope, connected to a urethane-filled hole, Clayey Levee.

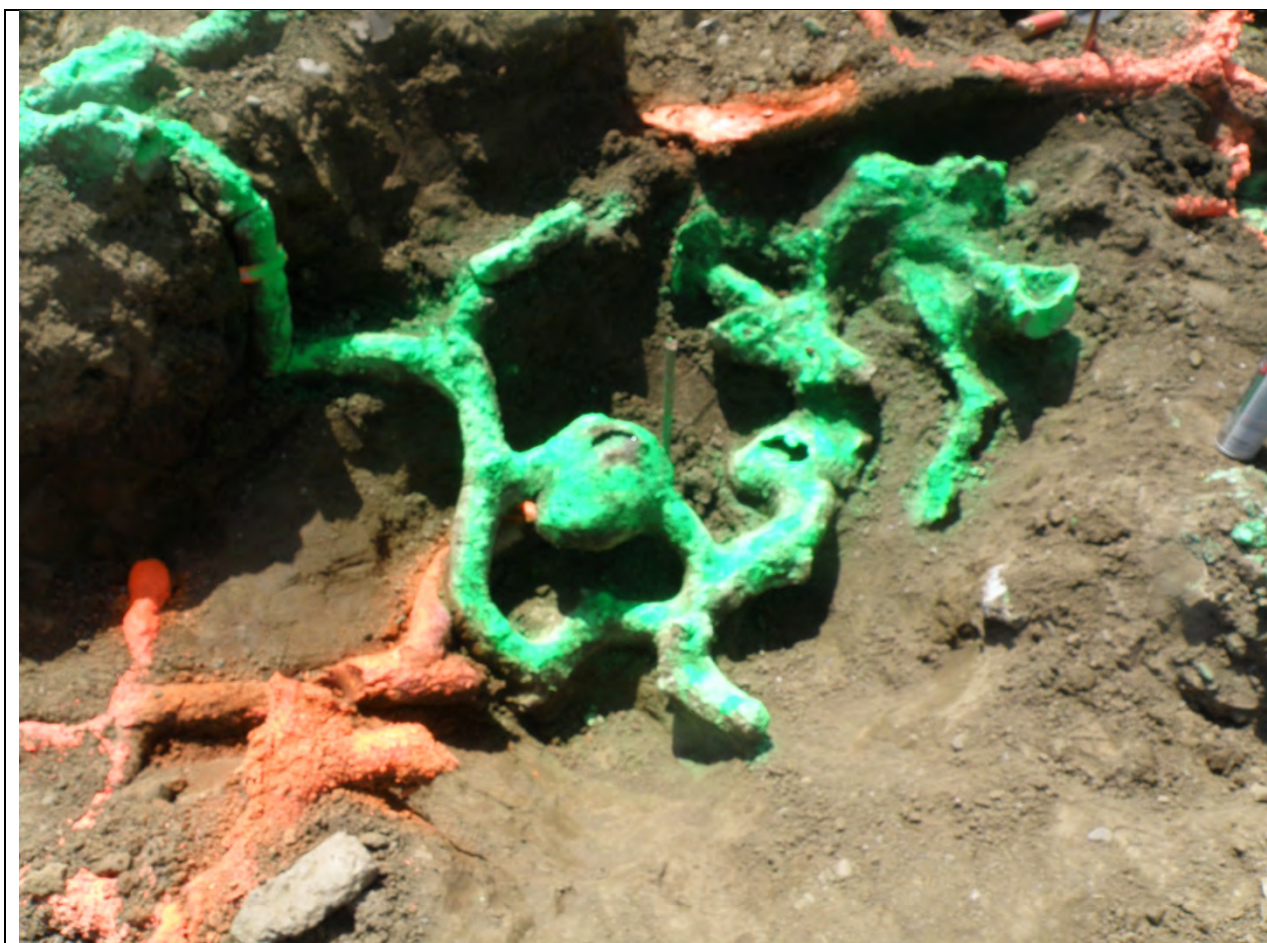
Photo 4A -29. Group of ground squirrel dens connected to smaller gopher holes, Clayey Levee.
